**UNDERWATER FACILITIES
INSPECTIONS
AND
ASSESSMENTS
AT**

**NAVAL STATION
ADAK, ALASKA**

**INSPECTION PERFORMED
AND REPORT PREPARED BY:**

**UNDERWATER CONSTRUCTION TEAM TWO
PORT HUENEME, CA**

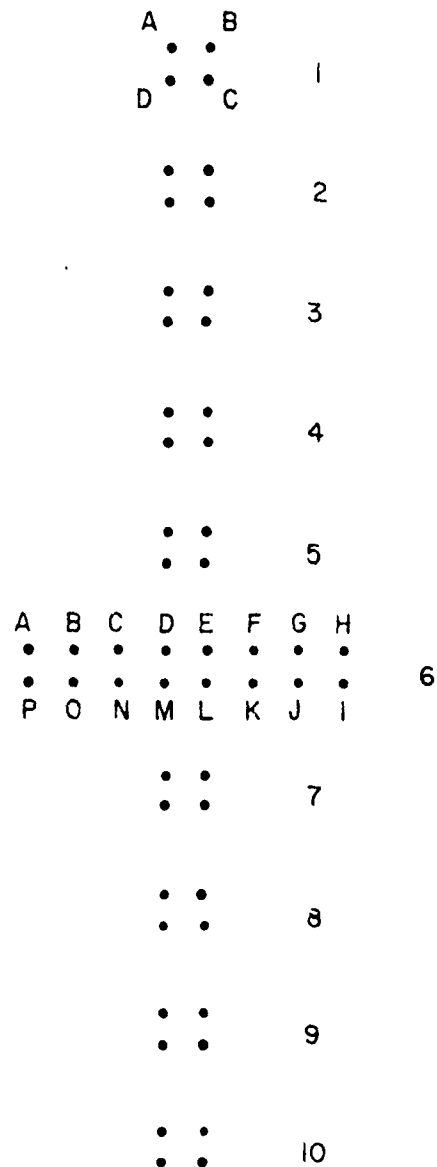
RUNWAY APPROACH LIGHT PILINGS

1. Commencing 16 July 1980 UCT TWO Det Adak inspected the runway centerline approach lights at Naval Station Adak, Alaska. The inspection data is referenced to Y & D drawing number 1,090,364, sheet 2 of 11. The runway approach light support pilings are 16 inch diameter creosote treated timber piles with tar impregnated burlap cap covers. There were a total of 10 bents with four vertical and four batter piles per bent.

2. A total of 56 piles were inspected from mud line to the high water mark. Since no as-built drawings were available a numbering system was established in which bents were numbered 1 - 10 going shoreward and batter piles lettered consecutively (see attached sketch). From the mud line to the high water mark, all piles appear in excellent condition. There exists a moderate growth of barnacles, and sea anemones and heavy kelp growth in the splash zone. Of the 56 piles, five had moderate damage ranging from evidence of marine borers to structural damage from apparent dredge cutter head contact or ship impact. Inspection sheets of all piles are attached as tab (A) of this enclosure. A sketch of pile placement and the numbering system used on the data sheets is included as tab (B).

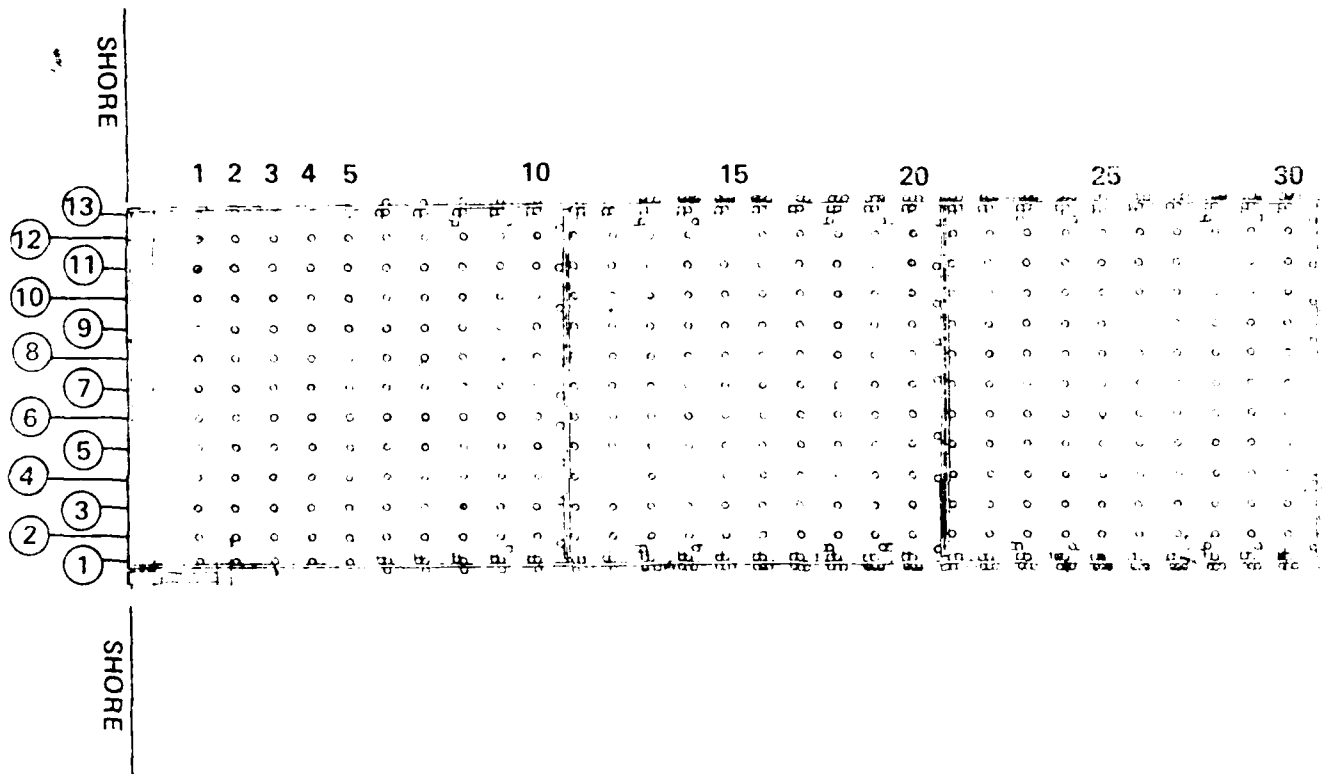
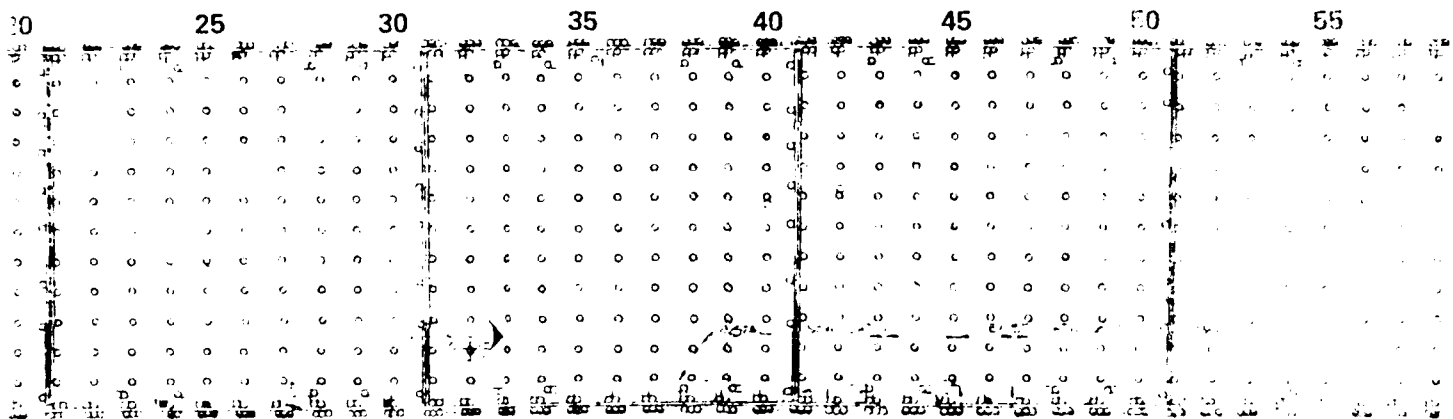
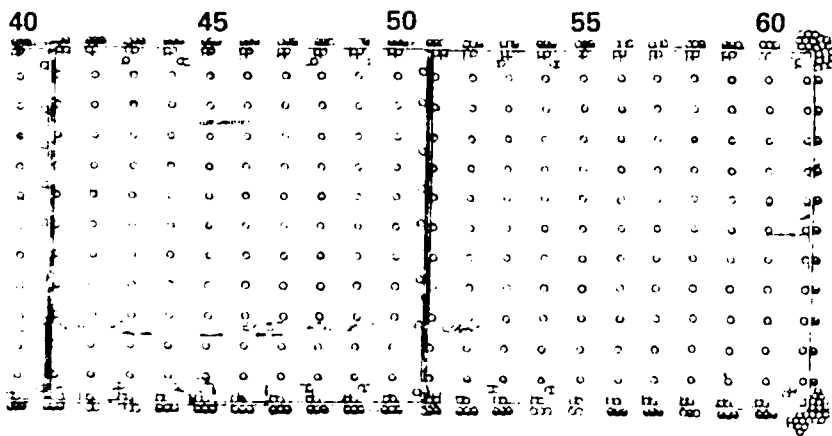
SUPPLY PIER

1. Supply Pier T-1403 was inspected by UCT TWO Det Adak, Alaska on 17-18 July 1980. This inspection data is referenced to NAVFAC drawing 6077551. The bearing piles supporting pier T-1403 are 16 inch diameter timber. There is a total of 780 piles with five firebreak walls. All firebreak walls appear in excellent condition. Incremental bore samples were taken on bents 6, 11, 16, 21, to determine the extent of creosote protection remaining within the pilings. Results indicated that between two and two and one half inches of creosote protection exists within the pilings sampled. There is from one to three inches of marine growth (consisting of kelp, barnacles, sea anemone) on all piles throughout the pier.
3. Inspection sheets are attached as tab (A) of this enclosure. Photos of the inspection are attached as tab (B).
